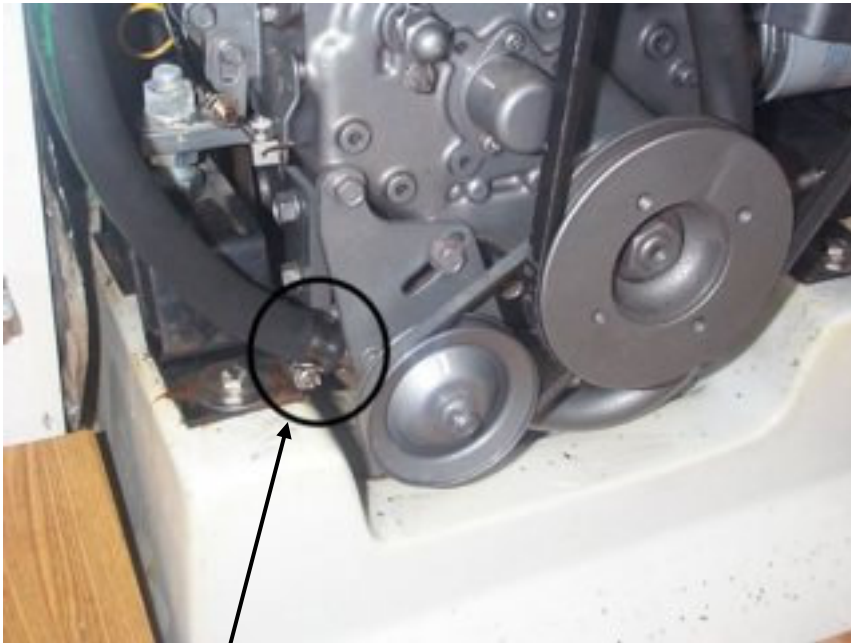
Recently a J/105 owner noticed rising water in his boat. After checking the through-hulls, he took the engine cover off and discovered that the water intake hose had come off the engine. The stem that the hose attaches to was too short for double clamps and the hose clamp that was there apparently loosened and/or vibrated off over time. He had to cut a short section of hose off to find good quality hose for the reconnection. The hose had disfigured as it gradually came off. The hose clamp has to fit very close to the end of the hose and close to the engine so that it is tightening on the coupling rather than half on and half off.

When he restarted the engine, there was still no water in the exhaust. Ultimately, he discovered that the blades of the impeller had all come off. Fortunately, none of them had been sucked into the heat exchanger.

Location of  
hose that came  
off engine

You may want to add this to the list of things your people check as they winterize our boats each year. Of course, owners should check this hose every time they check the engine oil levels.
